# Manhole Inspection Summary

Manhole # **S13GG\_047MH**

Insp Date: **2/23/09 2:11 PM**

**Location** Address: **2900 BRIGHTON ST** Cross Street: **POPLAR GROVE ST**

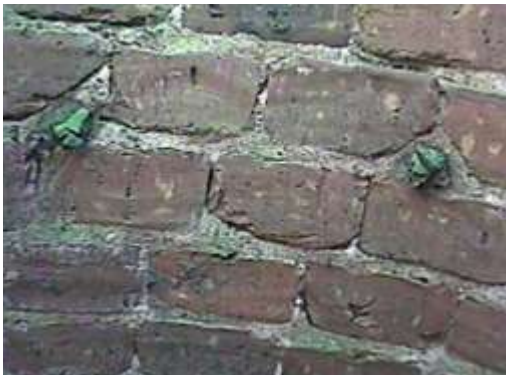
Defect 1

**Steps** Count: **7** Missing: **4** ☒ **Corroded**

MISSING/CORRODED RUNGS

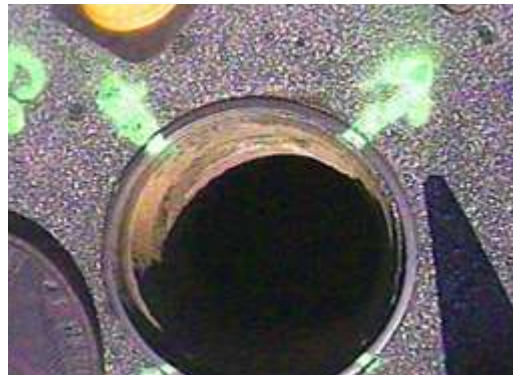
Defect 2

**Chimney / Frame Adjustment** ☒ Exists Material: **Brick and Concrete** ☐ Parged Height: **5** (in.)

Condition: ☐ Sound ☒ **Cracked** ☐ Root Intrusion ☐ Loose Brick ☐ Deteriorated

cracks at chimney

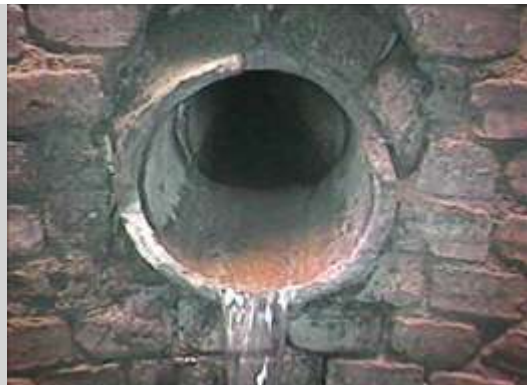
3 O'Clock Inflow

12 in. Circular Gravity Sewer  
Pipe In @ 3 O'Clock

Infiltration: **None** Pipe Seal Cond: **Broken**

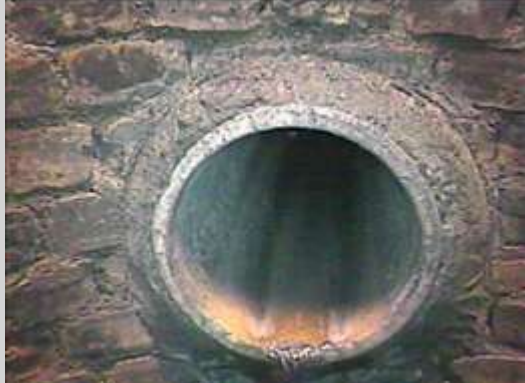
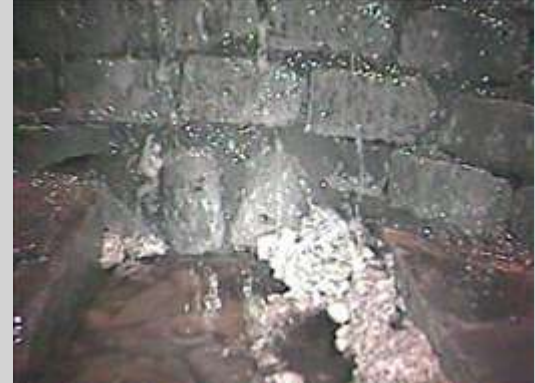
6 O'Clock Inflow

12 in. Circular Gravity Sewer

Pipe In @ 6 O'Clock

Drop In @ 6 O'Clock

Deposits: ☐ None ☐ Mud ☒ Sludge ☒ Debris ☒ Grease

Silt Depth: **10** (in.) Deposits Extent: **Heavy**

Drop: **Outside Direct**

Inv Depth: **14.57** (ft.)

Drop Condition: **Clogged**

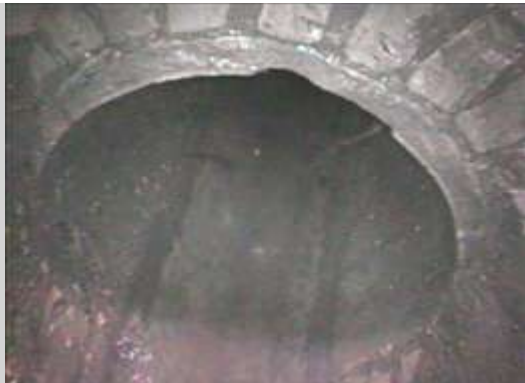
9 O'Clock Inflow

30 in. Circular Gravity Sewer

Pipe In @ 9 O'Clock

Infiltration: **None** Pipe Seal Cond: **Broken**
